FLOOD PROTECTION SCHEME

NEWTON STEWART FLOOD PROTECTION SCHEME – SUPPORTING DOCUMENT
GEOMORPHOLOGY IMPACT ASSESSMENT

118908/DOC/200/006/02

06 DECEMBER 2018

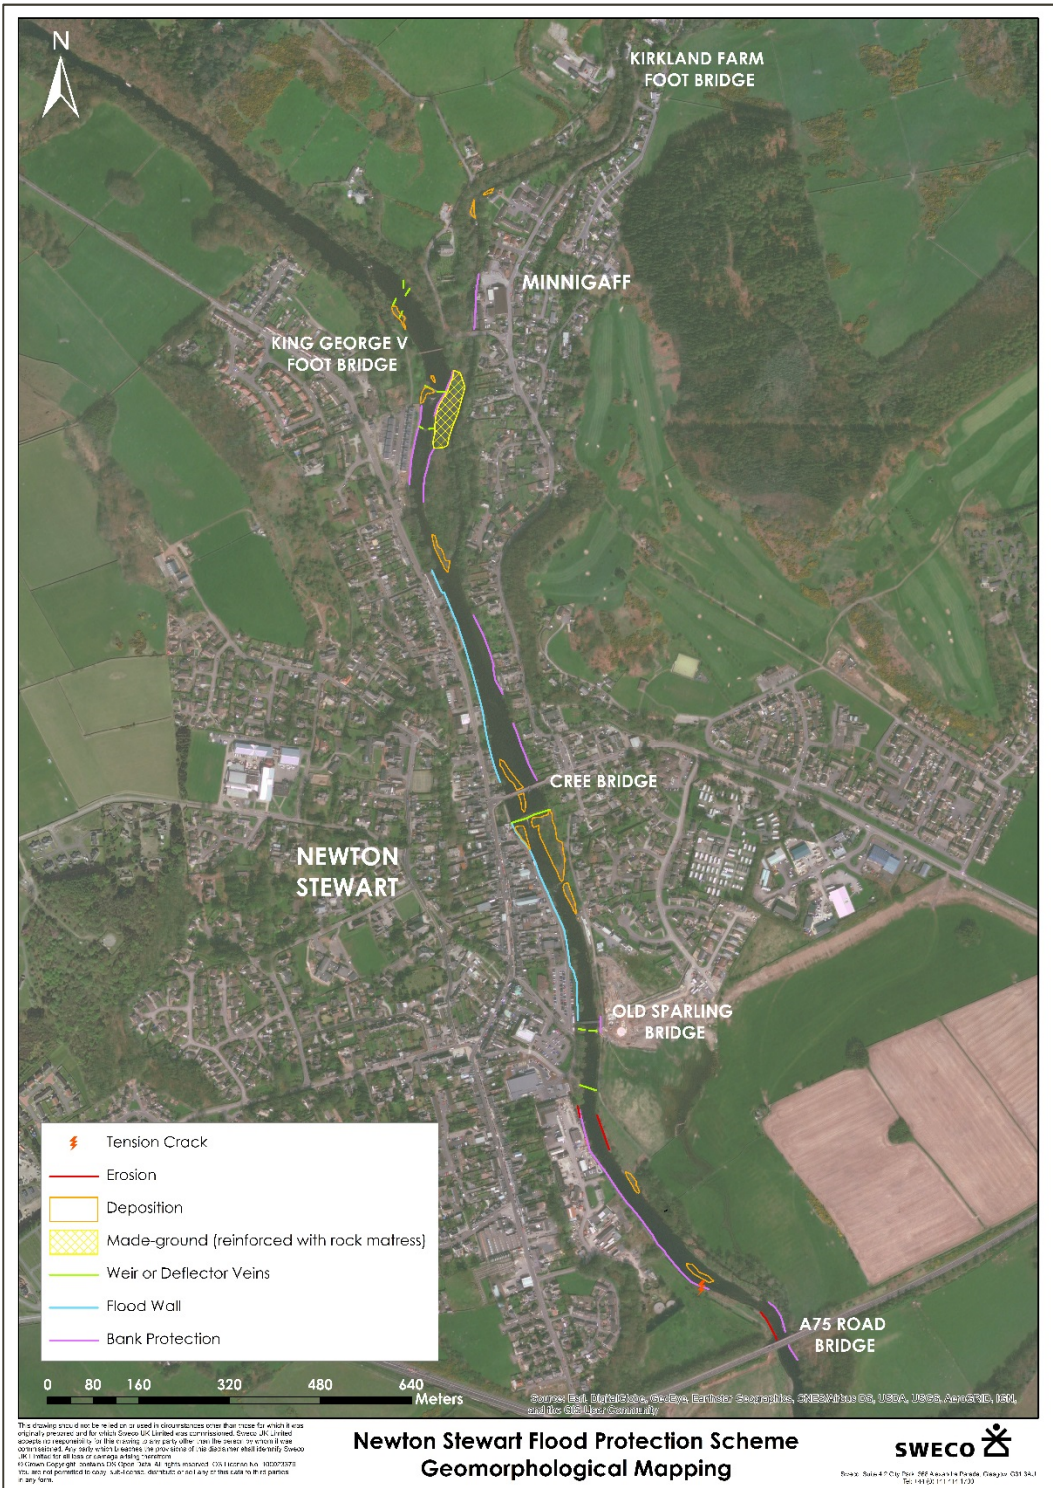
Figure 2. 4 Map showing locations of geomorphic processes and morphological pressures

Results of the River Reconnaissance survey are summarised below and are presented in full in Appendix A –. A map indicating the locations of geomorphic processes and morphological pressures is provided in Figure 2.4.

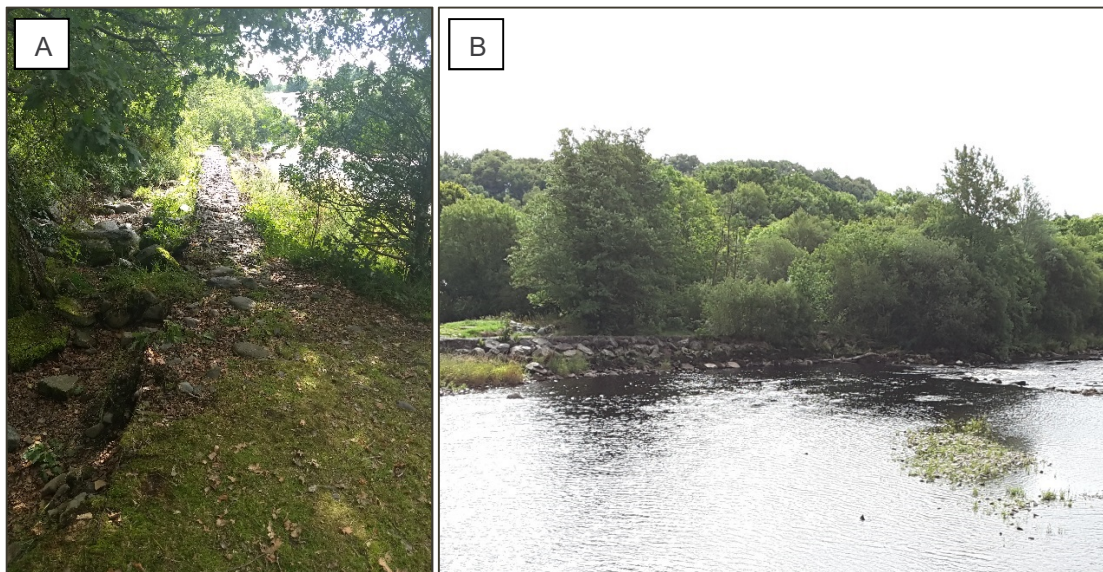
There are several morphological pressures on the upstream reach of the River Cree. There is a flood wall, which extends down the right bank, from the confluence with the Penklin Burn to the Cree Road Bridge. There is also extensive hard bank protection, on both banks throughout most of the reach, including the made-ground behind Mill Island. A rip-rap revetment was observed do (Figure 2.5). Flow deflection veins ('croys') are in place both upstream and downstream of the King George V foot bridge. These, combined with the bank protection and armoring, prevent the channel avulsing and returning to a more natural course. In addition, the Cree Road Bridge adds significant morphologic pressure to the river due to the large in-stream bridge footings (Figure 2.6).

Figure 2. 5 (A) Rock mattress reinforcement on the surface of the made-ground behind Mill island. (B) Rip-rap revetment on the left bank of the made-ground behind Mill island.

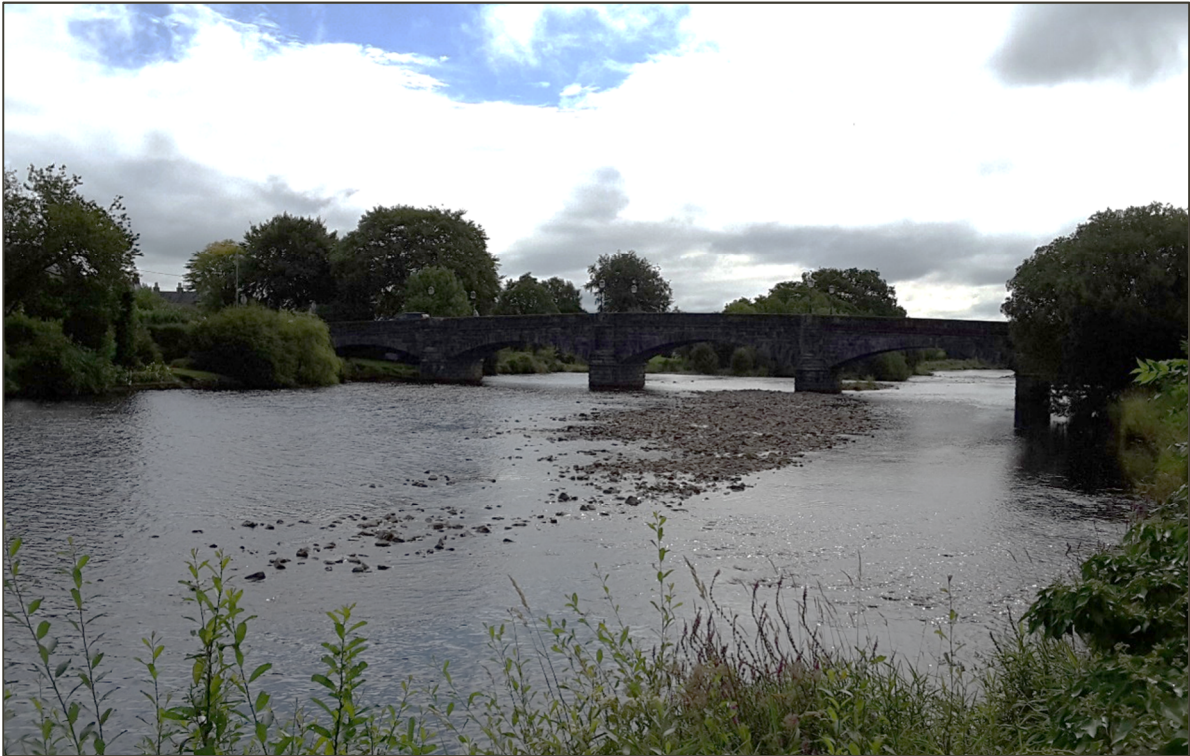
There was limited evidence of erosion on the banks along the reach. This is likely due to the extensive bank protection and re-grading of the banks throughout most of the reach. Several areas of deposition were observed during the site visit, particularly downstream of the croys in the section upstream of the Penkiln Burn confluence, and upstream of the Cree Bridge (Figure 2.6). There is also a large junction bar at the Penkiln Burn confluence.

Figure 2. 6 Cree Bridge taken from upstream looking downstream. A large depositional bar has been deposited upstream of the bridge.

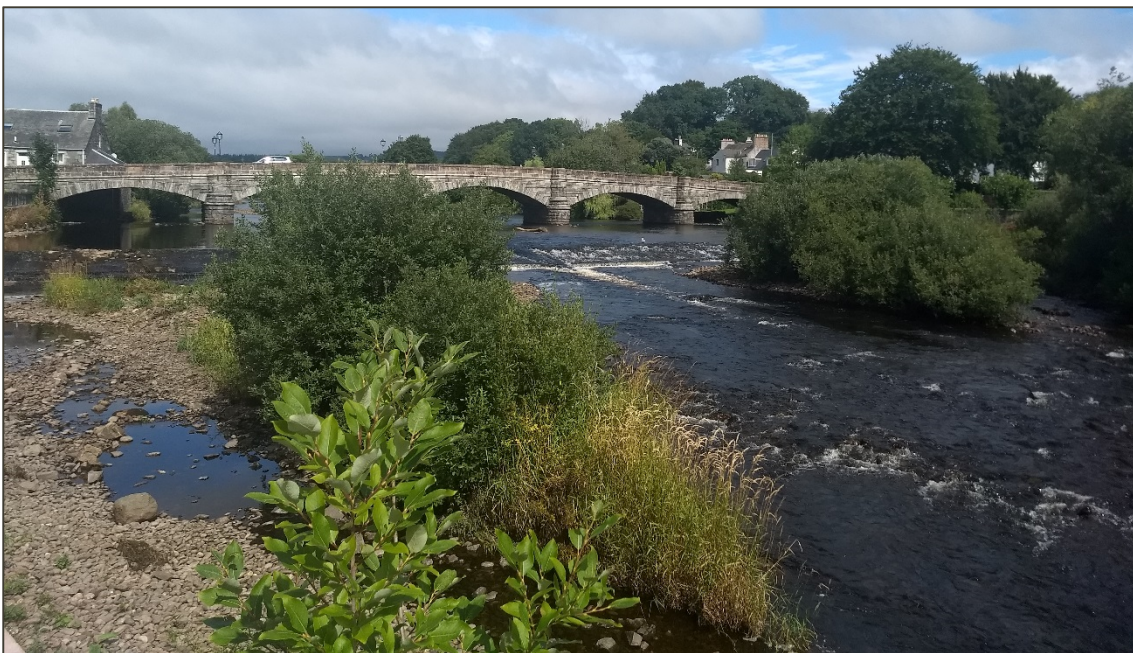
Figure 2. 7 Photo showing the weir on the River Cree downstream of the Cree Bridge. Deposition has occurred downstream of the weir.

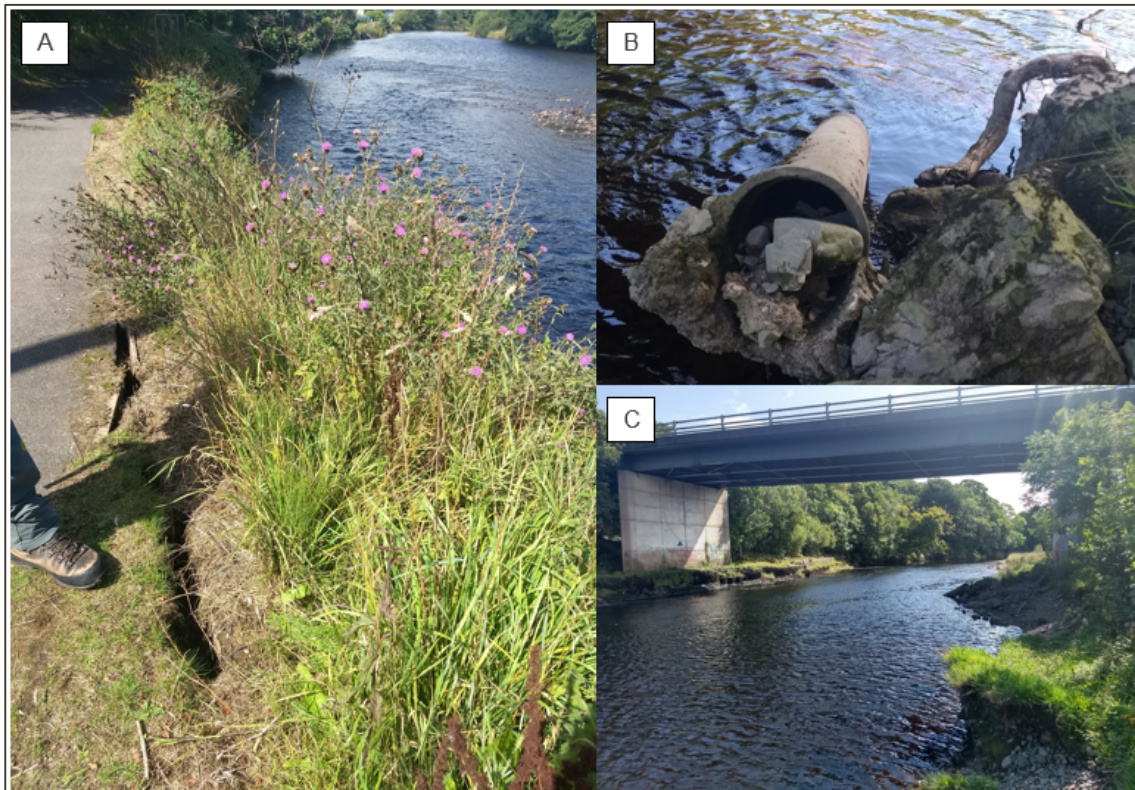
In addition to the weir, there are several other morphological pressures. There is a flood wall located on the right bank of the river between the Cree Road Bridge and the Old Sparling Bridge. There is also extensive bank protection down the right bank of the river, extending from the timber yard to just upstream of the A75 Road Bridge. The bank protection here is in the form of gabion baskets, which were observed to be failing in several locations.

A 30-cm deep tension crack was observed along the edge of the footpath at the top of the right bank, at the bend in the river just upstream of the A75 Road Bridge (Figure 2.8A). The gabion baskets appear to have failed in this section, and the bank is slumping due to erosion at the toe. Downstream of this location, the right bank of the river is undercut due to scour around the A75 Road bridge. A failed outflow pipe, and 'bulging' gabion baskets were observed under the road bridge (Figure 2.8B). The road embankments from the A75 are causing flow constriction under the bridge, resulting in increased scour in this area.

Figure 2. 8 River Cree, close to A75 road bridge (A) Tension crack along the footpath at the top of the right bank, upstream of the bridge. (B) Failed outflow pipe on the right bank under the A7 bridge. (C) Scour under the A75 road bridge (taken from the upstream of the bridge, looking downstream).

The gabion baskets along the right bank of the River Cree, from the proposed location of the new Sparling Bridge to the A75 road bridge are showing signs of failure in multiple locations. These will need to be removed as part of the re-profiling of the channel in this section. Due to the high potential for scour in this section, bank protection will still be required for the two-stage channel. Gabion baskets are generally not recommended as, due to their permeability, they are susceptible to failure requiring costly repairs.

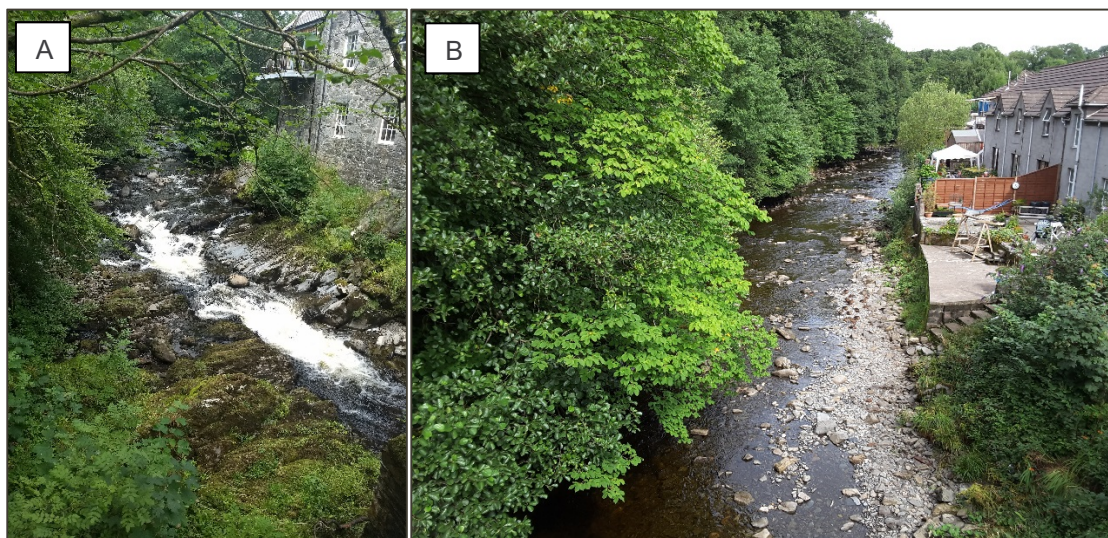
There was little evidence of bank erosion on the Penkiln Burn, however basal scour was evident from the exposed bedrock in the base of the channel. Deposition was evident throughout the reach by the presence of lateral and medial bars.

Morphological pressures on the Penkiln Burn include a road bridge, and bank protection along the gardens of the houses upstream of the Penkiln Road Bridge (Figure 2.9, Figure 2.3). Additionally, as noted above, the made-ground behind Mill Island has resulted in relocation of the confluence between the River Cree and the Penkiln Burn. This man-made ground has been reinforced with rock mattresses, which adds pressure to the channel.

Figure 2. 9 Penkiln Burn (A) Bedrock exposed in channel at the Kirkland Farm footbridge. (B) Bank Reinforcement in gardens upstream of the Penkiln road bridge.

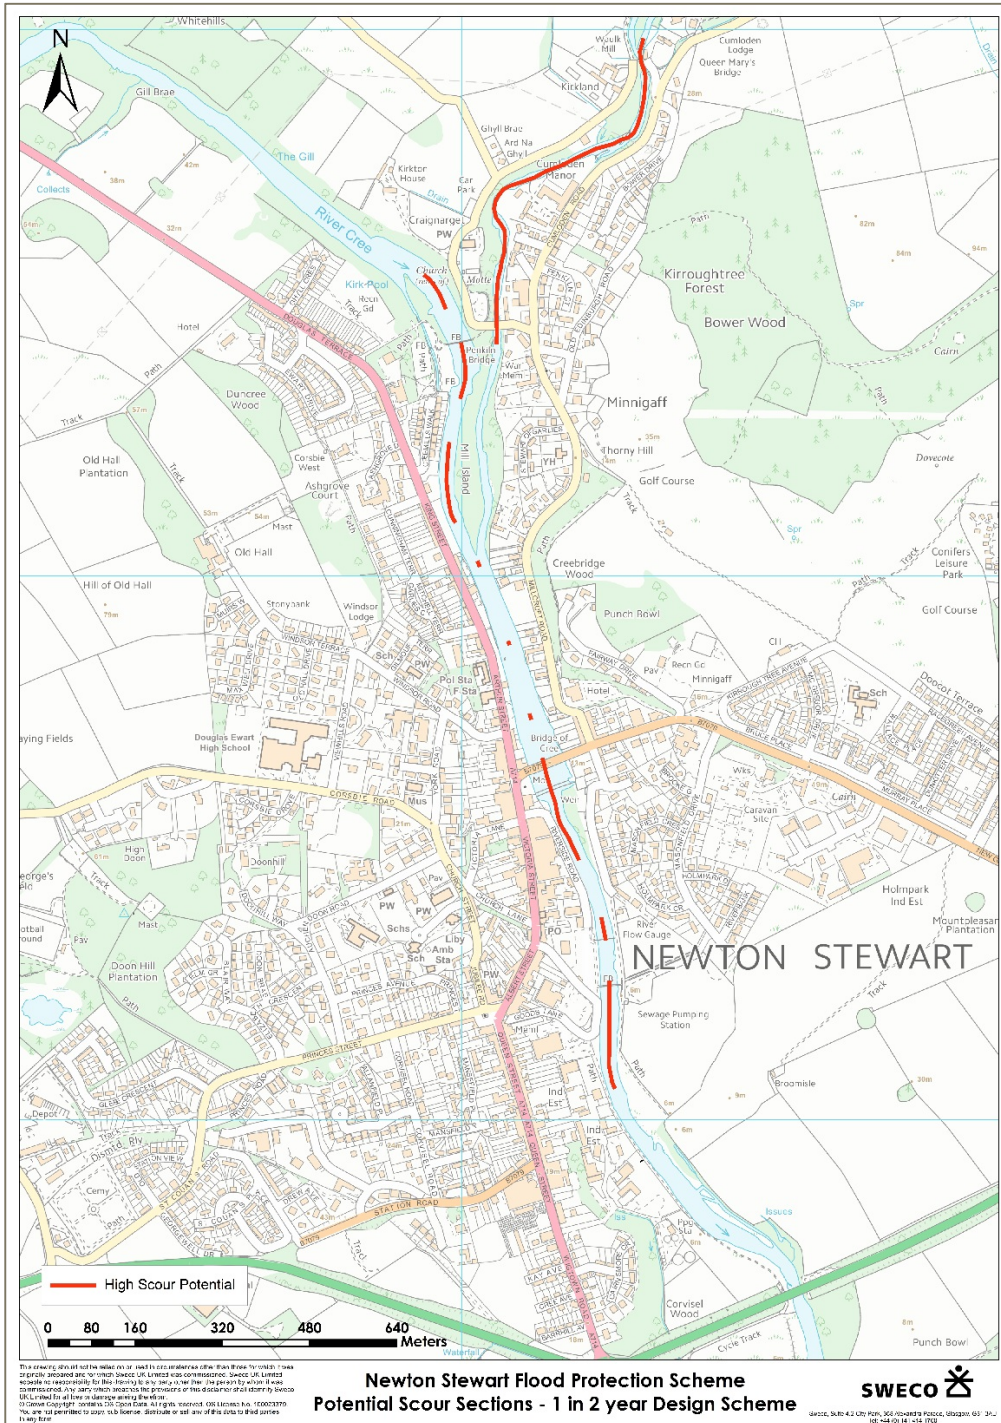
Appendix B – Scour Potential 1 in 2-year Event

The results indicate that there are extensive areas of high scour potential throughout the lengths of the River Cree and the Penkiln Burn in the project area. A section of potentially high scour is predicted to occur on the upper reach of the Penkiln Burn due to the steep gradient of the channel, resulting in high velocities in this section. However, scour will be limited by the bedrock, which is exposed in the base and sides of the channel. Scour potential is predicted to increase for the 1 in 200-year event, compared to the 1 in 2-year event along the Penkiln Burn. High scour potential is predicted along most of the Penkiln Burn for the 1 in 200-year event.

On the River Cree, extensive areas of potentially high scour are estimated to occur downstream of the Cree Road Bridge and the old Sparling foot bridge. This is likely due to constriction of flow due to the bridge abutments, resulting in increased flow velocities downstream. There is also high erosion potential downstream of the foot bridge at Ghyll Crescent on the River Cree, adjacent to the made ground behind Mill Island. This is likely due to relocation of the confluence with the Penkiln Burn, and higher rates of erosion may be due to the river attempting to return to its natural course.

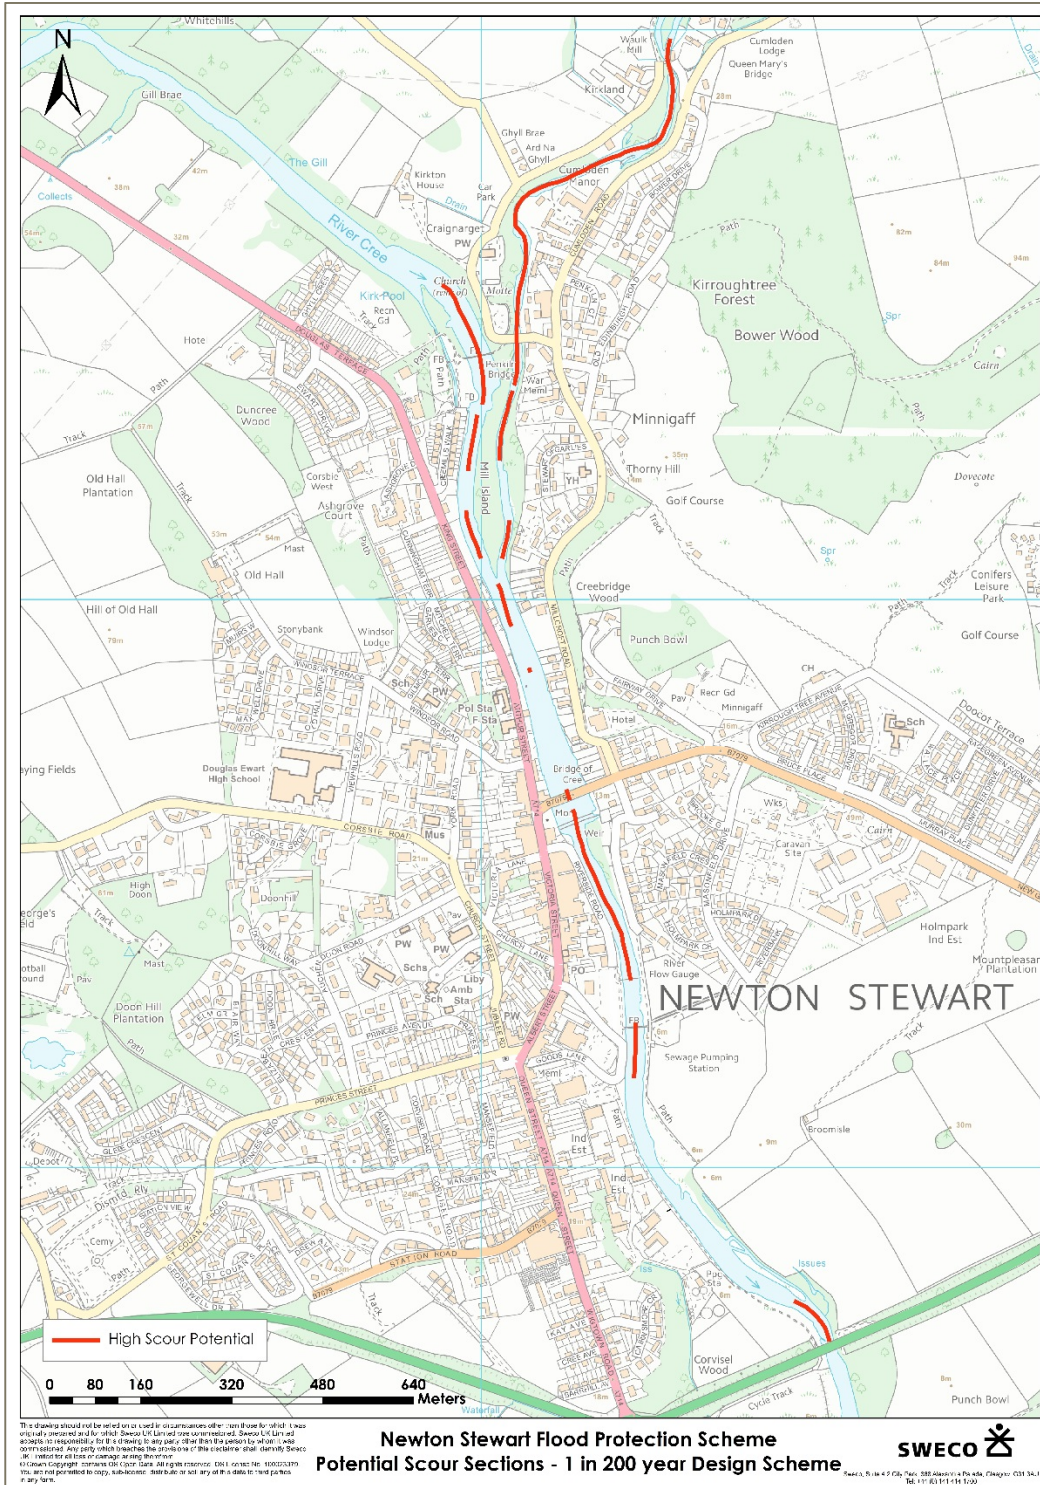
Appendix C - Scour Potential 1 in 200-year Event

Scour potential increases for the 1 in 200-year event compared to the 1 in 2-year event along the River Cree. For the 1 in 200-year event potentially high scour is predicted upstream of the A75 road bridge. This is due to the high volume of water backing up behind the bridge, resulting in increased water depths and increased scour.
