FLOOD PROTECTION SCHEME

NEWTON STEWART FLOOD PROTECTION SCHEME – SUPPORTING DOCUMENT
GEOMORPHOLOGY IMPACT ASSESSMENT

118908/DOC/200/006/02

06 DECEMBER 2018

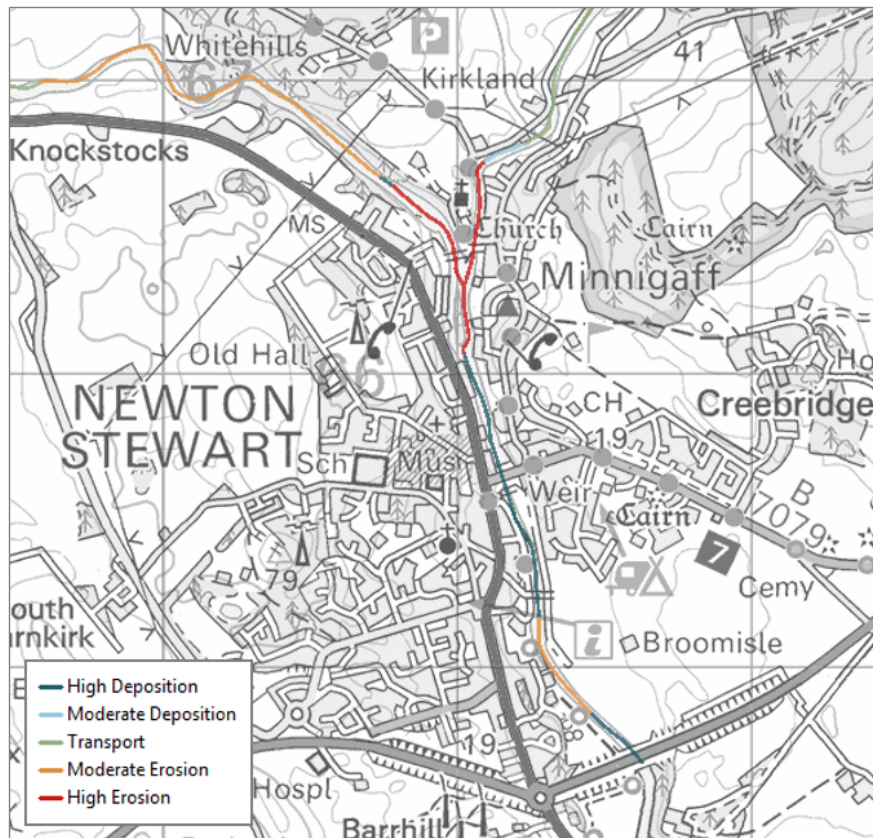
SEPA's flood maps² indicate that there are high rates of geomorphic activity on the rivers within Newton Stewart (Figure 2.2). On the River Cree, there are high erosion rates both upstream and downstream of the Penkiln Burn confluence, and high rates of deposition both upstream and downstream of the Cree Road Bridge and upstream of the A75 Road Bridge. On the Penkiln Burn there are high rates of erosion upstream of the River Cree confluence.

Figure 2. 2: SEPA's Flood map showing rates of geomorphic activity on the River Cree and Penkiln Burn

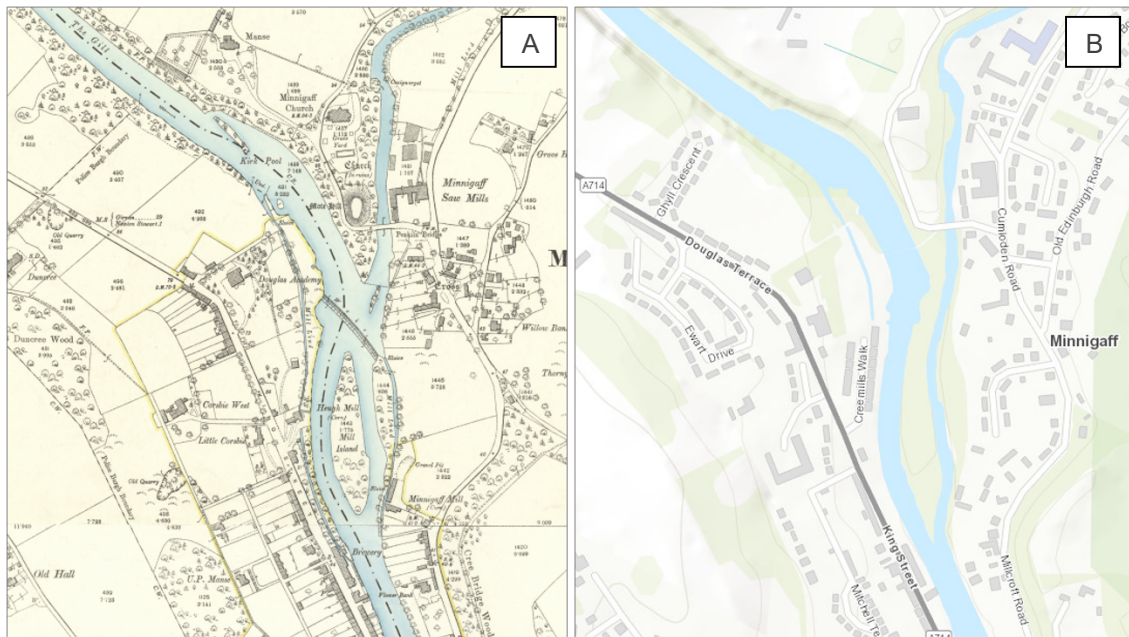
Analysis of historic OS mapping³ indicates that the confluence of the Penkiln Burn with the River Cree was previously located approximately 400 m upstream of its present location (Figure 2.3). Land has been built up behind Mill Island to separate the River Cree from the Penkiln Burn, relocating the conference to the south of Mill Island.

Figure 2.3 Comparison of historical and current OS mapping showing changes in location of the confluence between the River Cree and the Penkiln Burn (A) Historical OS map from 1842-1914 (B) Current OS map.
